Weathering of the lime sandstone used for building the farmhouse in Strtenica (Slovenia)

The farmhouse in Strtenica, situated in the eastern part of Slovenia (Fig. 1), represents an important piece of cultural heritage. The seven stone buildings (Fig. 2) are unique in Slovenia, above all because of the sandstone, which is the prevalent type of building stone in this part of Slovenia. Buildings made from sandstone are mostly weathered after 170 years. The farmhouse is a typical example of Slovenian vernacular architecture from the nineteenth century.

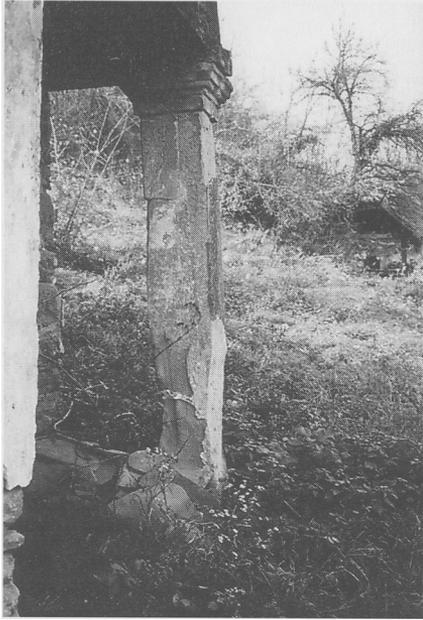
The pillar of stairs (Fig. 3) is used as the representative case of weathering. The pillar is built in such a way that its longer axis runs parallel with the direction of the layer. The crustation of layers is seen as the consequence of such a position. A 1-cm-thick layer of sandstone is weathered in the upper part of the pillar. Weathering continues with the appearance of relief with thin crusts. Weathering is most expressed in the lower part of the pillar as stone bursting, because of the crystallisation of gypsum.

FIG. 3. Damaged stair pillar from the house used as the inn.

The chemical composition of the pillar changes, depending on the distance from the surface. Changes can be seen in Table 1. Changes in chemical composition coincide with different mineral composition depending on the distance from the surface of the damaged pillar. Leaching of SiO_2 and Al_2O_3 and

enriching of MgO and CaO are seen at the surface because of gyps crystallisation near the surface of the pillar.

The substitution of the damaged parts of sandstone objects with original sandstone from the stone quarry in the vicinity of the farmhouse is suggested. Painting, similar to methods used in the past, should be used as the protection.

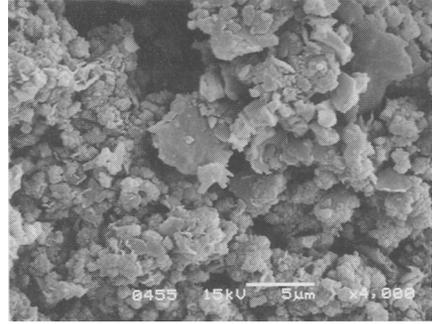
FIG. 5. Crystals of gypsum, SEM.

Leached calcite reacts with the pyrite and crystallises in gyps. Crystals of gyps are seen in Fig. 5.

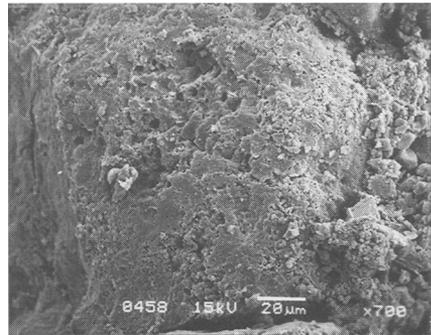
FIG. 6. Leached surface of feldspar.

The leaching of feldspar is seen in Fig. 6.

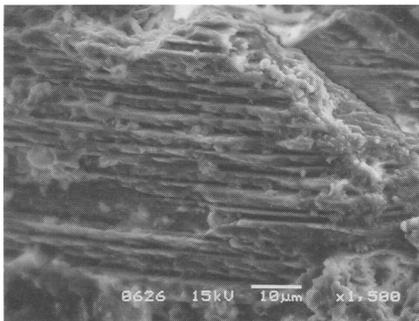
Quartz, calcite, muscovite K-feldspar, plagioclase and gyps are found at the surface. Quartz, calcite, muscovite, and K- feldspar can be detected at a depth of 10 cm. The selective leaching of calcite (Fig. 4)

and crystallization of gypsum are seen at the surface.

FIG. 4. The leaching of calcite crystal is seen as the lamellar surface of calcite crystal.
