## ARCHITECTURAL CONSERVATION AND APPLIED MINERALOGY

RICHARD A. LIVINGSTON

### ABSTRACT

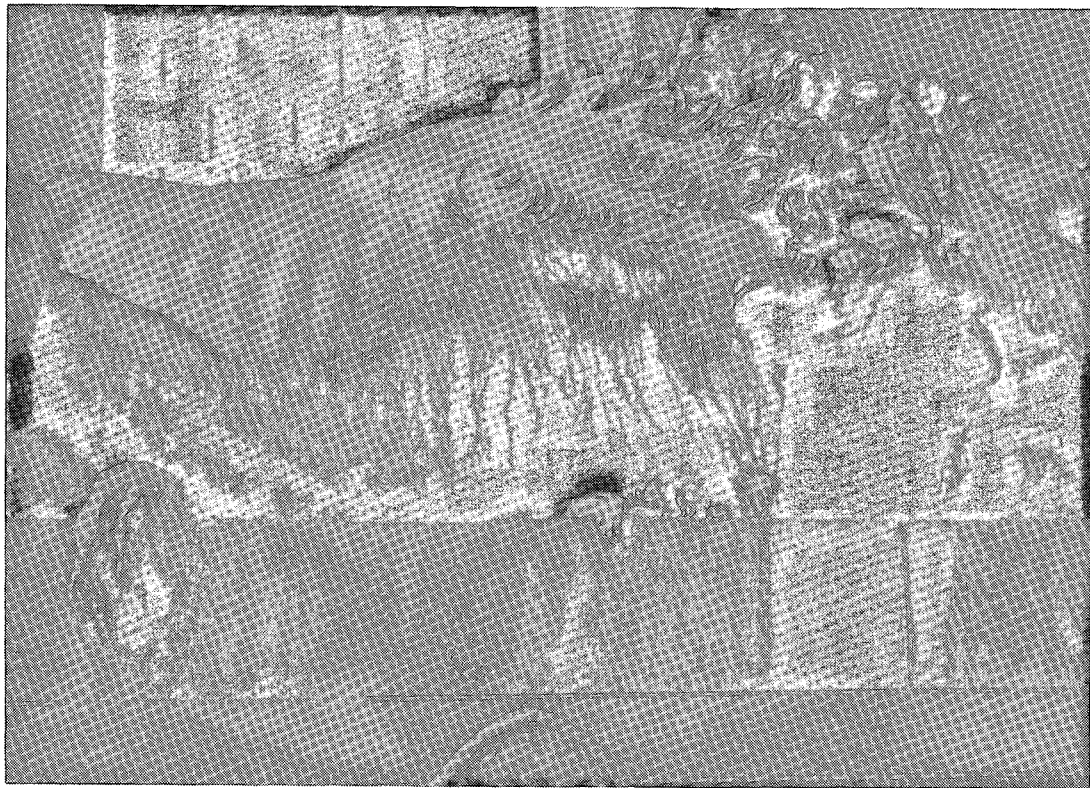
FIG. 4. Streaks of color on bronze statue due to differences in contact with rainwater. Also, stains on marble pedestal due to runoff of soluble copper salts. Corcoran Gallery of Art, Washington, D.C.

A third type of material interaction can be observed where a bronze statue is placed on a marble pedestal. The result is frequently a greenish blue staining of the marble due to soluble copper compounds being dissolved from the statue (Fig. 4). As the runoff washes over the marble, the copper is deposited on the stone. Although this effect has been known and studied for many years (Kessler & Anderson 1953), very little has been published on the mineral species involved. In some cases, marble deterioration has been observed, but in other cases, it has not. Consequently, it is not possible to say

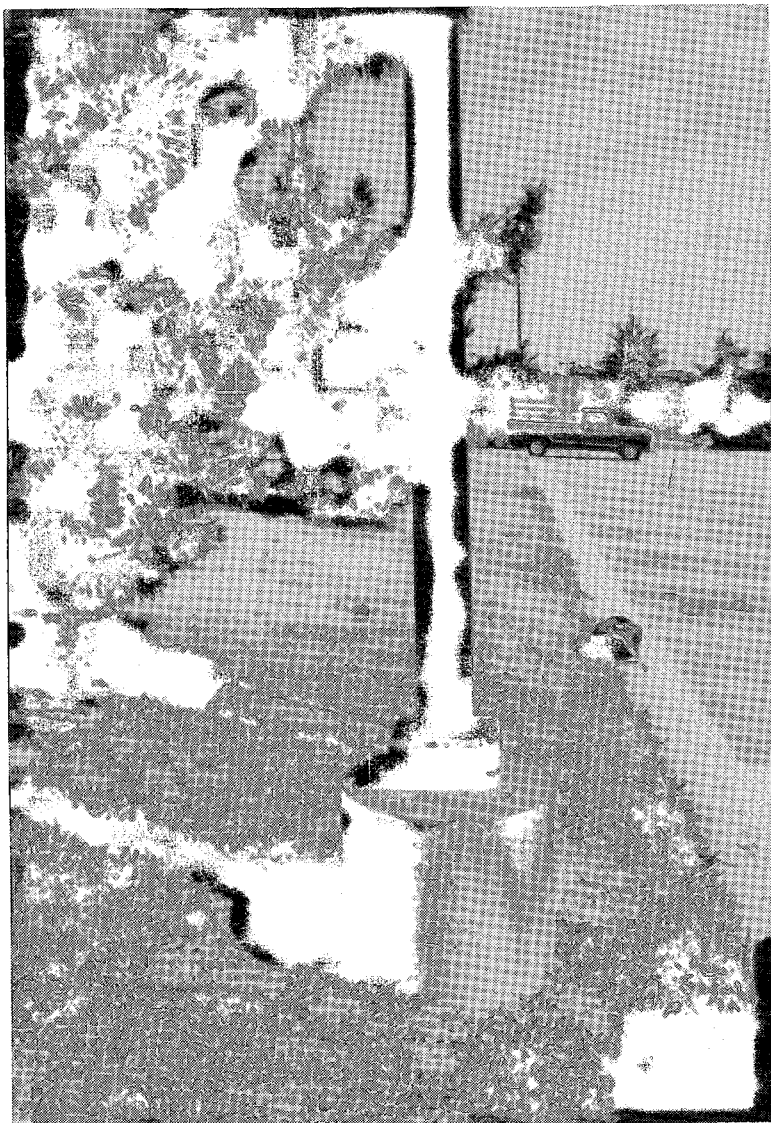
FIG. 8. Staining of concrete by runoff from weathering steel. College Park, Maryland.

Another type of staining problem occurs with weathering steel. As noted above, its durability derives from the stability of the rust layer, which develops as copper is concentrated in the surface layer. During the initial period, while the layer is being built up, there is a significant amount of iron that washes off and can stain concrete foundations (Fig. 8). These wash stains are typical of weathering

steel construction and, in some cases, may be objectionable on esthetic grounds (Evans 1968).
